# DOWNTOWN TOLEDO WATERFRONT INSPECTION

TOLEDO, OHIO

DECEMBER 2019

PREPARED BY:  
**THE MANNIK & SMITH GROUP, INC.**  
1800 INDIAN WOOD CIRCLE  
MAUMEE, OHIO 43537

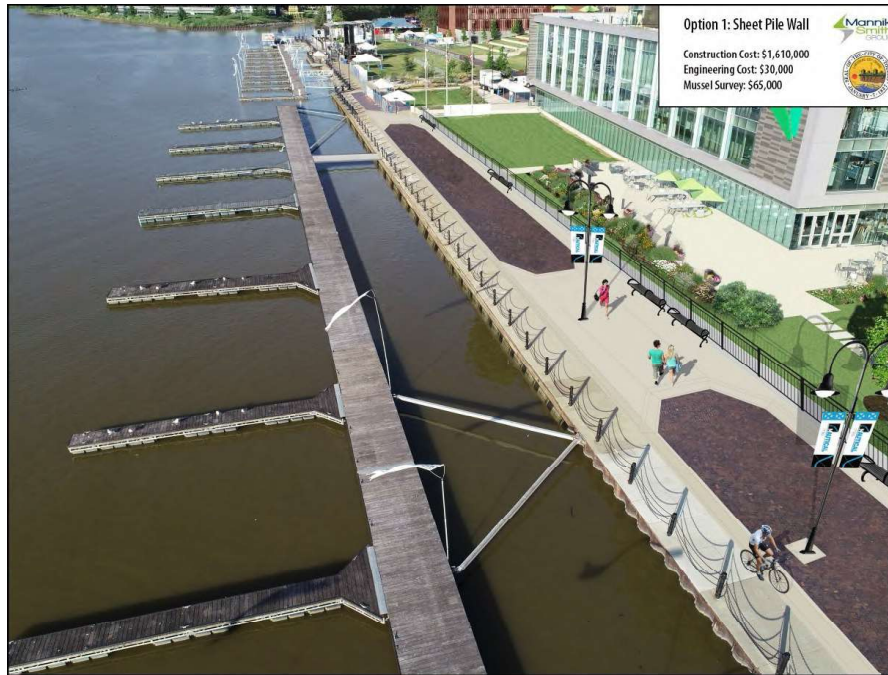
## Option 1 - Replacement with Steel Sheet Pile

The concrete slab and pile cap wall in front of the ProMedica is in **Poor Condition**. The beginning portion on the north end (station 2+00 to 2+25) has failed and is beginning to slump. The concrete pile cap in this area has completely eroded and the two transverse diaphragms in this area exhibit the greatest amount of open corrosion. Currently, the section is being held up by a single reinforcing steel bar that has begun to bend. The remainder of the exterior concrete cap is in similar condition, though not as severe. The bottom of the concrete slab has exposed steel with up to 100% section loss. A load rating was performed on this section of wall and it was determined that nothing heavier than a pickup truck (not an ambulance or a fire truck, for example) could be driven on the slab, if the failing area between station 2+00 and 2+25 was repaired in kind. The recommendations for this section of wall are as follows:

- **The sidewalk from station 2+00 to 2+25 should be closed to all traffic, including pedestrians, until the portion of wall is repaired.** (Structural)
- **The entire concrete slab and pile cap wall between station 2+25 to 4+75 should be replaced with a steel sheet pile wall to match the adjacent sections.** (Structural)

The total costs for this repair option is estimated at **\$1,705,000**.
